DOT	US Department of Transportation
PHMSA	Pipelines and Hazardous Materials Safety Administration
OPS	Office of Pipeline Safety Eastern Region
Principal Investigator	Al Schoen
Region Director	Byron Coy
Date of Report	04/28/2011
Subject	Failure Investigation Report – Sunoco R&M Flange Gasket

Failure Investigation Report – Sunoco R&M Flange Gasket

Executive Summary

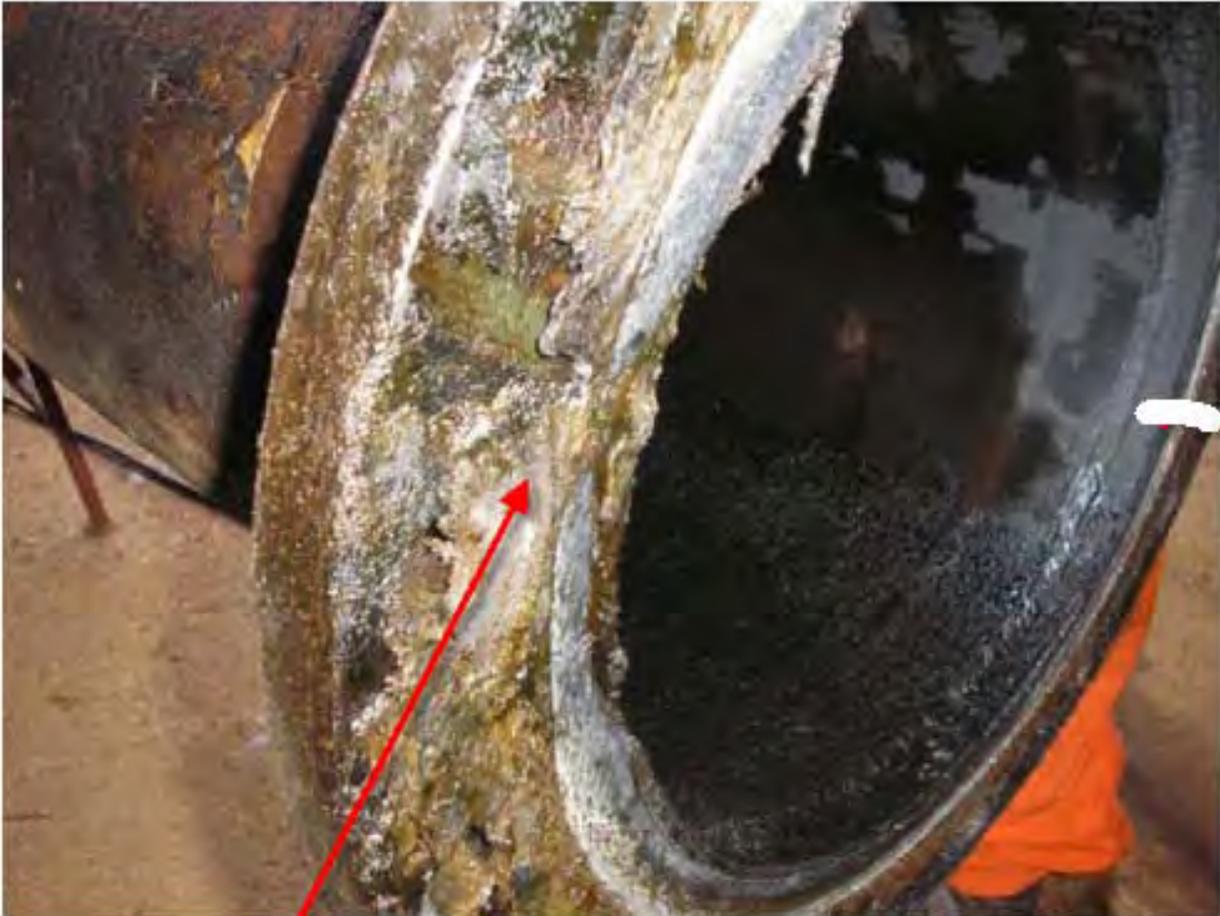
Photo 3 – Flange Gasket

The mechanical failure of the Mainline valve seat and gate allowed product to pass into the section of piping including the failed flange. Failure of the paper gasket in the flange caused the flange to leak.

Paper gasket eroded at leak location (orientation about 8:30)

It is concluded that the lack of support at the center flange, allowed pipe movement over time, including movement caused by thermal cycling, which applied a differential stress on the flange bolts and eventually caused the flange to open at the 8:00 o'clock position. The FM-1 trap inlet/outlet valve was found to have a mechanical defect which prevented a tight shut-off, which allowed product from the FM-1 pipeline transfer to pass through the valve, into the pig trap, causing the release from the center flange. No corrosion of the flange faces or other mechanical damage was observed.

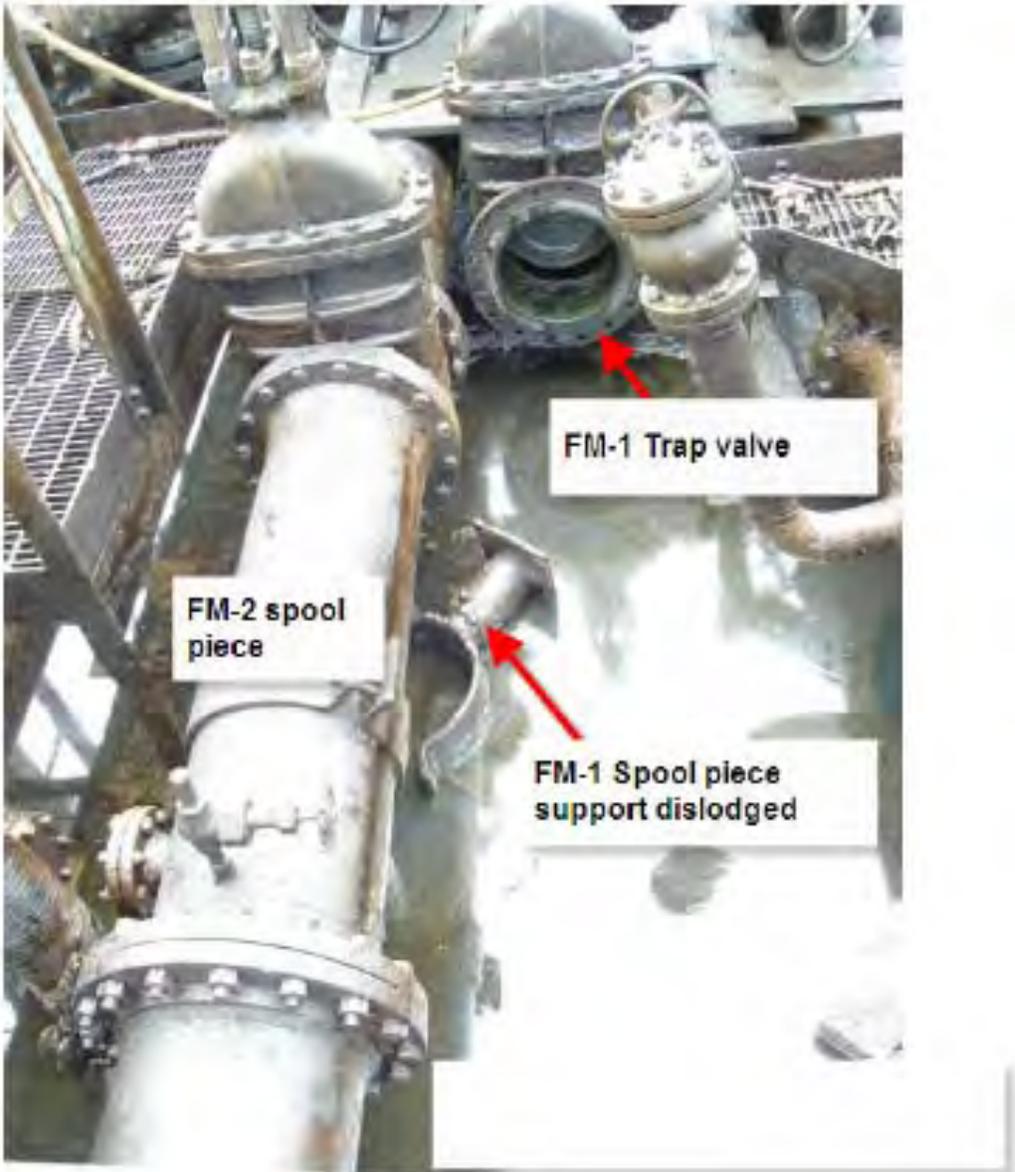
Photo 6 – Spool Piece Support

The loss of pipe support and leakage through a closed valve contributed to the failure (Appendix B).

The FM-1 pig trap was about 39 1/2' in length, measured from the flange at the inlet/outlet valve to the flange at the closure. The trap was initially supported at three locations. The trap was supported at the containment wall around the manifold, 9'-4" from the flange at the closure. The trap was also supported by its flanged connection to the inlet/outlet valve. Due to its length, it was also supported, adjacent to the failed center flange. The center flange was 5'-0" from the inlet/outlet valve. The center support is believed to have been located in the 5' spool, within 12" from the center flange. The support consisted of a structural column, a base plate at the bottom that rested on the floor of the manifold containment, and a two-part clamp-style fitting at the top which secured the support to the outside diameter of the carrier pipe. Once the FM-1 trap was removed, the center support was found in the containment, detached and separated from the FM-1 trap piping.

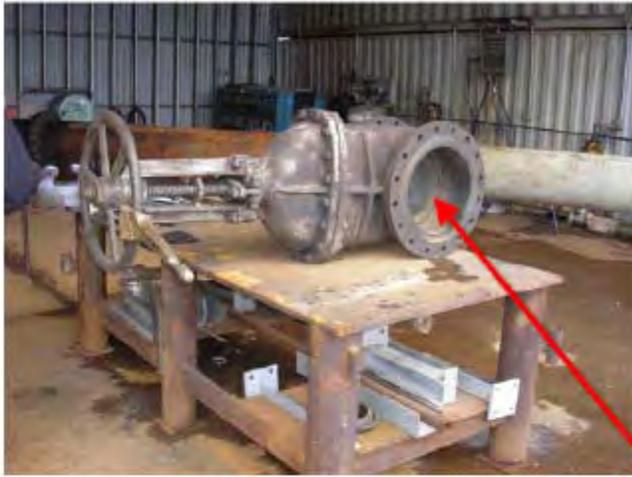
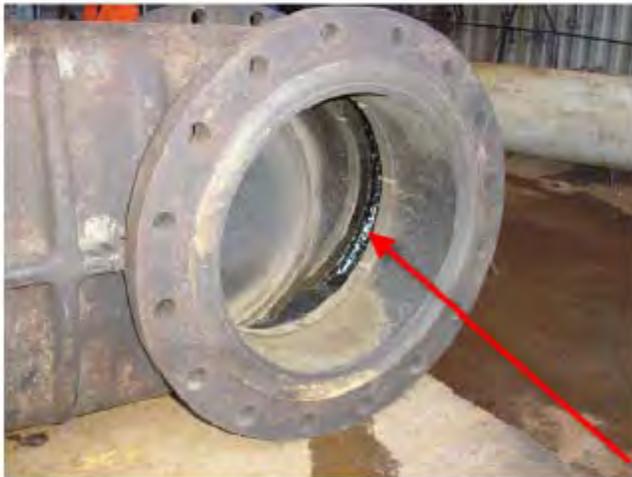
Photo 7 – Trap Valves

to stop short of full closure.

16" Trap Inlet/Outlet Valve appeared

scale was removed from gate cavity...

Residual heavy oil containing metal

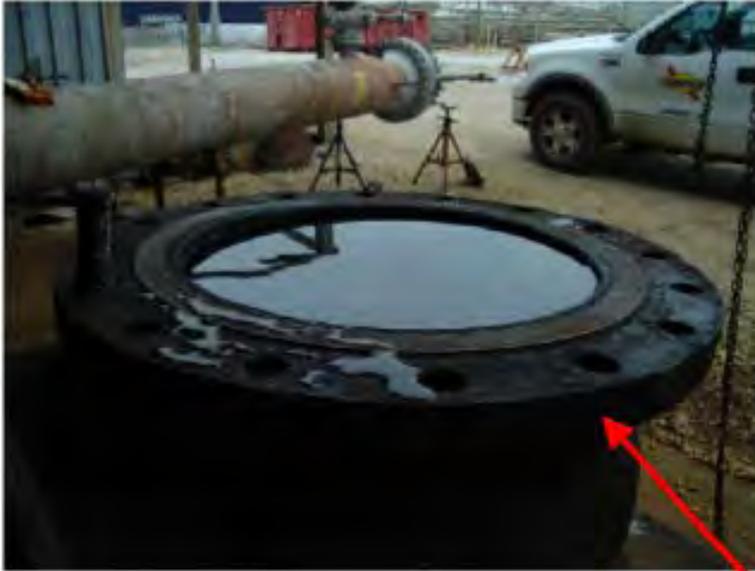
Photo 8 – Trap Valve Test

FM-1 Trap valve found to have a mechanical defect preventing a tight shut-off during seat test.
